### **Glinton: St Benedicts Church – Advisory Repairs**

*Completed by Regional Clockmaker Joe Mines on the 27<sup>th</sup> of January 2021.*

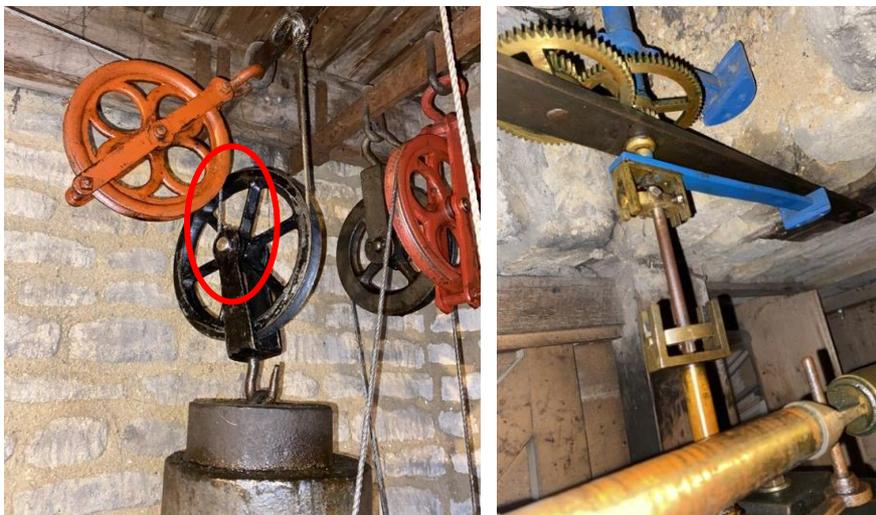
“On arrival the clock was stopped and after investigation I realised this was down to a number of issues. Firstly, the clock had been overwound and the weightline had come off the pulley, I reconnected this and set this up but some replacement weightline would be beneficial as it has slightly frayed where it has come off. The second reason the clock had stopped was that the fly arbour stops had come out, I replaced these and set this up. Finally, the hands were jumping forward around 5mins when they reached 12 on the dial because the T-join had wear, where the conrod connects to the dialworks. I replaced the T-join, and this reduced the jump by 4mins but there is still a small jump of about 1min. This is being caused by the end square on the clock hands with the issue feeding back through the clock system, addressing this issue would be beneficial. We would have to remove the hands and dialworks back to our Derby workshop so the end square can be repaired, dialworks stripped and cleaned before being re-balanced.

*Left: The pulleys where the weight line had come off (in red circle). Right: The T-join that was replaced on the dialworks.*

To conclude, the clock was left in working order, but I would advise that the weightline is replaced and the hands and dialworks overhauled. This would negate the jumping of the hands and reduce the likelihood of the weightline coming off the pulley, but this can always be caused if the clock is overwound.”

We propose to remove the hands from the outside of the tower before withdrawing the dialworks (ratio gearing located behind the clock dial) from the inside of the tower. In our Derby workshop the end square and spindle ends, on the hands will be re-profiled, the dialworks cleaned and lubricate before the hands and dialworks are re-balanced. We will return to install these back into their original position, so the issue with the hands jumping by 1min will be negated. Our engineer will also replace the weightline with new 6mm stainless-steel weightline, so this is also in good working order.
